## Fatigue Failure of Alloy Grade P22 Hot Reheat Auxiliary Steam Pipe

### ABSTRACT

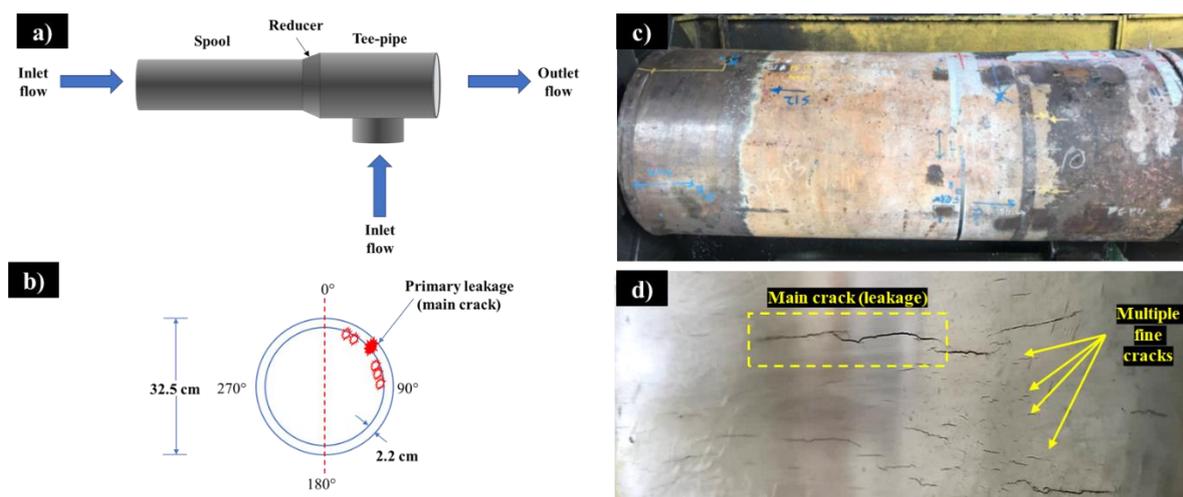
The material is a hot reheat auxiliary steam pipe that experienced leakage. The pipe has been operating for more than 130,000 equivalent operating hours (EOH) in a cyclic-load operating power plant. The operating temperature and the operating pressure were 540 °C and 49 bar, respectively. Figure 1 a) depicts the failure of the auxiliary pipe components, which include the pipe spool, reducer, and T-joint. The through-wall crack was identified in the spool pipe. The pipe was found to have bulging and cracks at the base metal area. Multiple linear indications were found at the base metal near the weldment of the spool and reducer. The main crack occurred in the spool over an arch length of 0° to 90°, as shown in Figure 1 b). Figure 1 c) shows the as-received spool sample and Figure 1 d) shows the 0° to 180° side of the sectioned pipe with a circumferential main crack through (leakage) as well as multiple fine cracks on the internal surface.

**Figure 1.** a) General illustration of the spool, reducer and tee-pipe b) cross-sectional view of finding on spool c) as-received spool and d) 0° to 180° side of the internal sectioned pipe with the presence of numerous circumferential cracks.

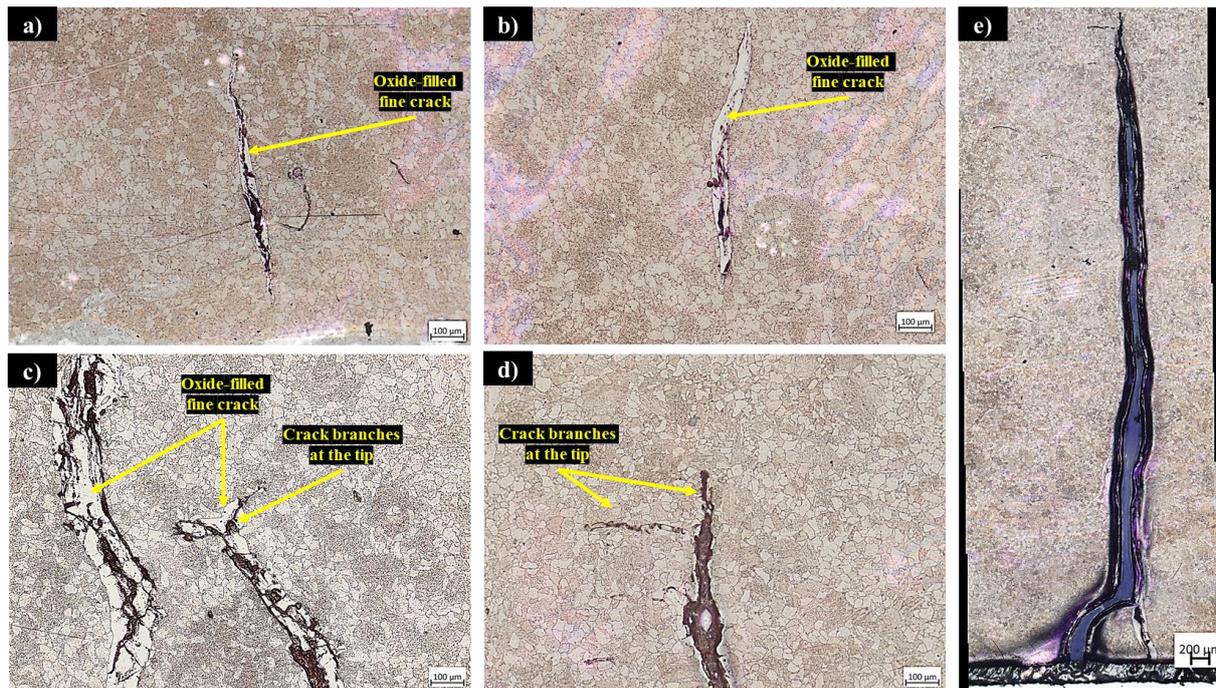
Figure 2 shows the microstructures of in-situ replication for P22 alloy etched with nital. All the microstructures show that the cracks occurred at the base metal. Figure 2 a) shows the unaffected area microstructure at the plane of 270° which consists of ferrite and bainite phases. Based on the thermal degradation classes as given by the Central Electricity Generating Board (CEGB), it shows that the microstructure of the as-received spool has degraded with bainite decomposition to class B, in which the carbides have spheroidized in a moderate manner, as compared to the new microstructure of tempered bainitic steel [9] which has well-defined bainite colonies. Figure 2 a) shows that the bainite phase has started to break up and the presence of carbides is observed in the base metal. Figure 2 b) and Figure 2 c) show fine cracks filled with oxide. Figure 2 c) and Figure 2 d) show the split at the crack tips of the main crack and fine crack, respectively. Figure 2 e) shows a sharp, straight primary crack. The main characteristic of the fine cracks associates with propagation in a transgranular mode and oxide-filled. Such a crack appearance is associated with fatigue [10].

**Figure 2.** Microstructure of in-situ replication P22 alloy etched with nital revealing a) unaffected base metal at the plane of 270° (magnification at 100X) b) fine crack (magnification at 100X) c) fine crack (magnification at 100X) d) crack tip of the main crack (magnification at 100X) e) crack tip (magnification at 50X)

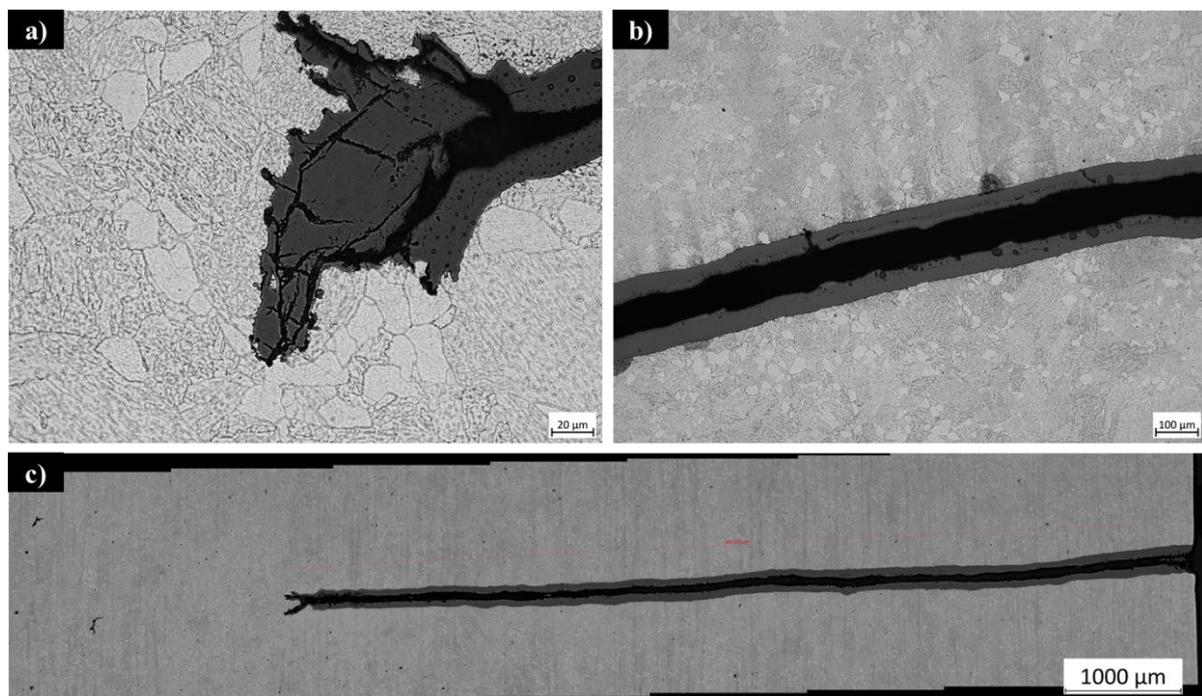
Figure 3 shows the microstructures of the mounted sample etched using nital. All the mounted samples show parallel cracks on the surface of the spool. The characteristics of the cracks are similar to those shown in replica films, which are multiple, parallel fine cracks that are propagated in transgranular mode and filled with oxide. Figure 3 a) shows the crack tip with small branches at the end, and Figure 3 b) shows the thick oxide layer in the crack. Most of the cracks are filled with oxides, which form at high temperatures and crack or rupture during operation cycles. The oxide layer filling the cracks is a mixture of dense and cracking/exfoliated layers due to its brittle characteristic.

Figure 3 c) shows the microstructure of the mounted transverse sample to show the crack depth. The crack was measured using ZEN Core 3.3. The crack shows a transgranular sharp crack with oxide filled and split ends. The deepest crack has already penetrated up to approximately 7.9 mm.

**Figure 3.** Microstructure of mounted P22 alloy etched with nital revealing a) oxide filled fine crack with branching tip (magnification at 500X) b) heavily oxidized cracking surface (magnification at 100X) c) crack depth (magnification at 50X)

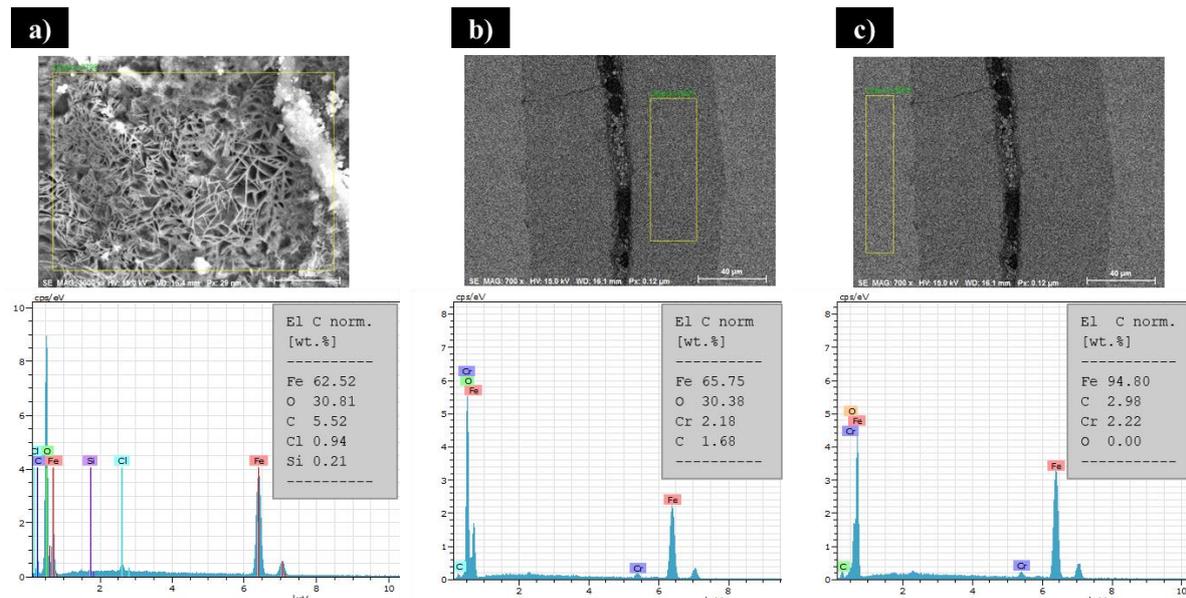
Figures 4 a), b) and c) show the EDX analysis of the oxide deposit, white phase at the crack, and base metal near the crack, respectively. Oxide deposits were collected at the internal surface using carbon tape. Figure 4 a) shows a high oxygen content (30.81%) in the deposits at the internal surface, which suggests the presence of oxide at the internal surface of the spool. Besides that, Figure 4 b) shows the EDX analysis of the unknown white phase. The result of oxygen content is quite high (similar to an oxide deposit), which suggests the white phase shown on the replica film, is the formation of oxide in the base metal. Figure 4 c) shows the EDX analysis of the base metal near the crack. The result of oxygen is relatively low, which is consistent with the chemical composition result of P22 alloy.

**Figure 4.** Multipoint EDX analysis of a) deposit at the internal surface b) white phase c) base metal.

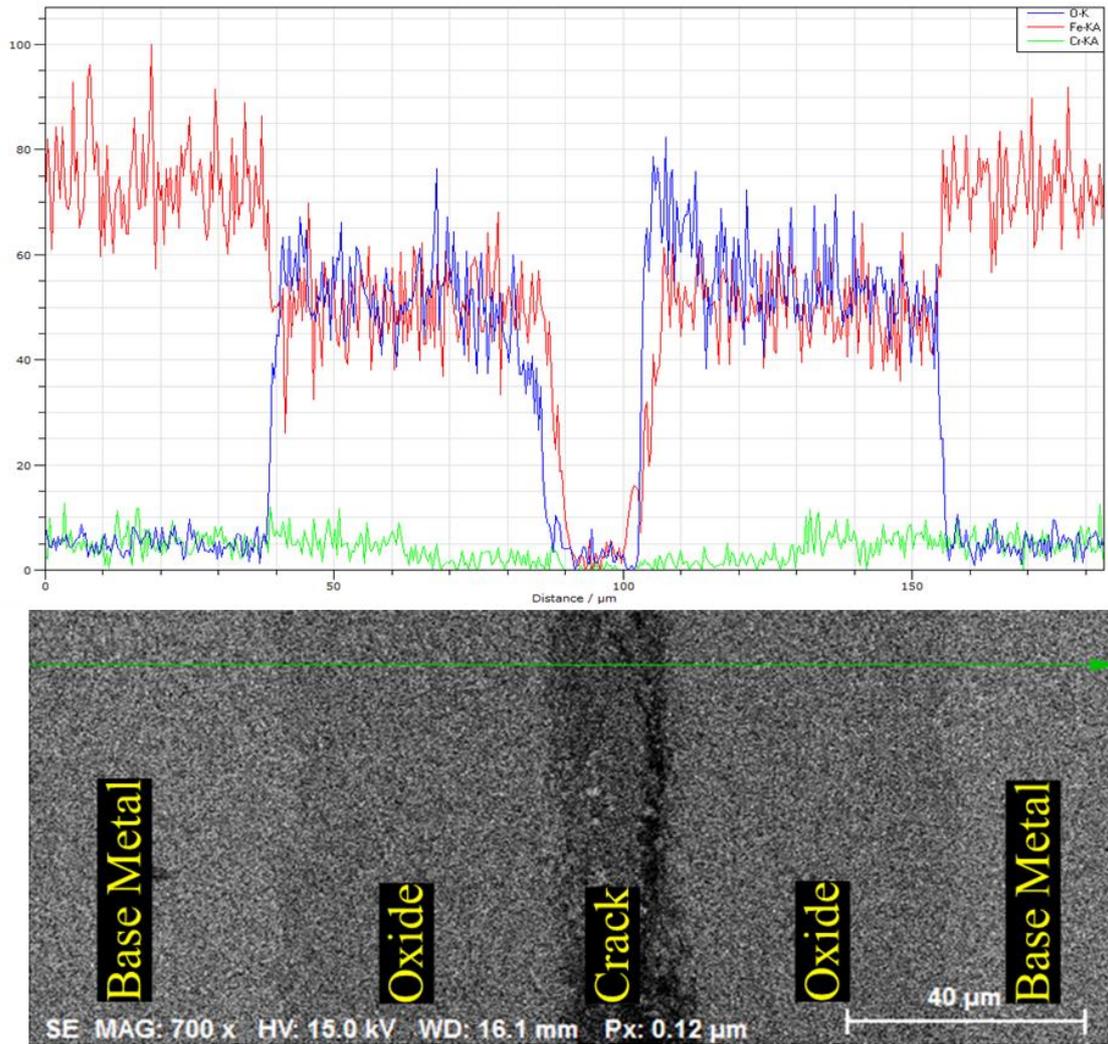
In addition, EDX analysis using the line profile scanning method was done to confirm the elemental composition of the crack as shown in Figure 5. The elements that were observed were oxygen (O), iron (Fe) and chromium (Cr). It shows that oxygen content rises rapidly at the unknown phase, which clarifies the phases as oxide. It was revealed that the oxide layer is mostly composed of magnetite ( $Me_3O_4$ ), when Me stands for metal such as Mo, Cr and Fe [5]. No apparent corrosive elements and no significant corrosion pits were found.

**Figure 5.** EDX profile scanning analysis relative to the region shown in the SEM.

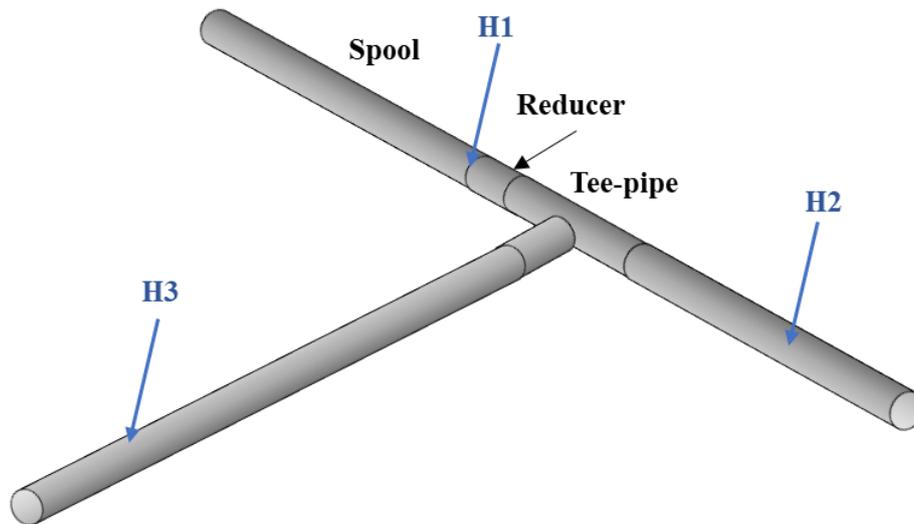
Additional information on pipe hanger inspection was obtained to identify the possible root cause of failure. It was reported that there are three hangers, which are H1 (constant hanger), H2 (rigid support) and H3 (variable hanger) in the neighbourhood of the pipe leakage as illustrated in Figure 6.

**Figure 6.** General illustration of nearby hanger location at hot reheat auxiliary pipe.

The inspection shows that H2 and H3 were still within the allowable range. H1, however, was reported in bottom over-scaled condition. A pipe hanger that is bottom over-scaled acts like a rigid hanger because it is unable to accommodate the pipe's thermal movement. The movement is constrained, and the pipe may experience increased stress as a result [12]. This suggests that the hanger is overloaded at that particular location where the hanger's suspended beam was found deformed. The malfunctioning pipe hanger could cause load transfer to adjacent piping sections [12] and introduce high-stress locations.

Besides, it was observed that some pipe snubbers of Hot Reheat Pipe (HRP) that connected close to auxiliary pipes showed signs of hydraulic fluid leakage, and fluid indicator showed low level or below minimum level or exhausted oil. As the snubbers hydraulic fluid was exhausted, it will not be functioning correctly. This condition is aggravated when air or dirt enters the snubber's valve. The snubber is used to protect the piping system from shock/transient load. When the snubber is not functioning correctly, it could not resist and protect the piping system from transient (as snubber freely slides; thus, it does not counteract the shock forces) [12]. Furthermore, broken pipe support strut ends, dislodged snubber pins and dislodged snubber ends were found on the HRP line show the sign of pipe snubbers have started to become malfunction. Based on the pipe hanger and support condition, it shows that the crack is likely attributed to the excessive cyclic stress on the piping system [12].
