## Creep Rupture and Thermal Shock Failures of Nickel-based Alloy Reformer Tubes: A Comparative Analysis

Nur Farhana Hayazi\*, Junaidi Che Halim and Ku Adri Azhan Ku Mohamad

*Surface Technology Special Interest Group, Faculty of Chemical Engineering and Technology, Universiti Malaysia Perlis (UniMAP), Arau, Perlis, Malaysia*

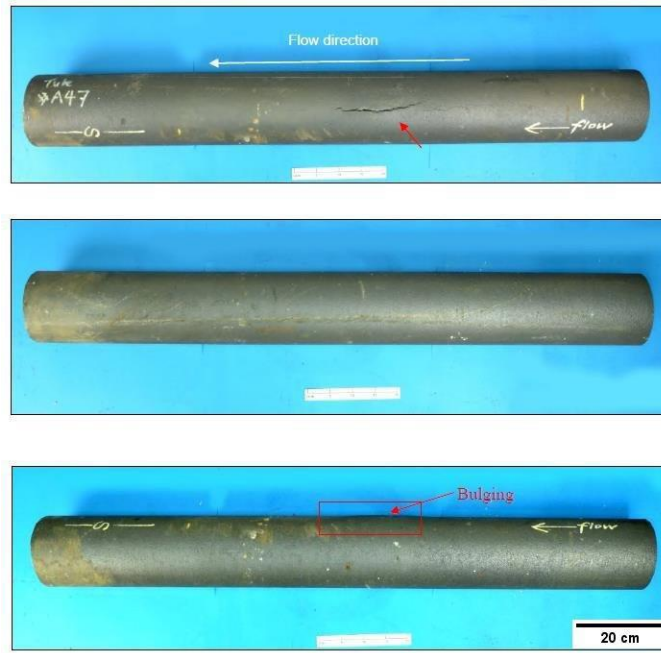
**Figure 1.** General Views of As-Received Tube A.

The received cut-out sections of the radiant tubes were examined visually and macroscopically accompanied by photographic documentation. Figures 1 to 9 present general and close-up views of the examined samples, A and B. Figures 1 and 2 show the general views of the as-received tube A and the outside diameter surface respectively. The cut-out tube was around 1300 mm long. The longitudinal rupture crack was 140 mm long, with a slight bulge at the crack mouth. Apart from the crack and fissures, the OD surface was generally intact revealing a darkish appearance. The crack had a jagged appearance (Figure 2) with fissures. The fissures were intermittent in nature and extended over a length of around 130 mm towards the top of the ruptured crack. The cracks and fissures were oriented along the same axis on one side of the tube circumference.

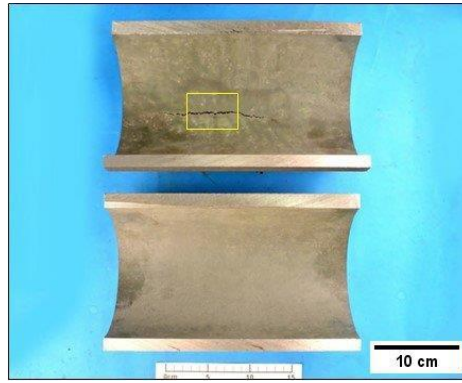
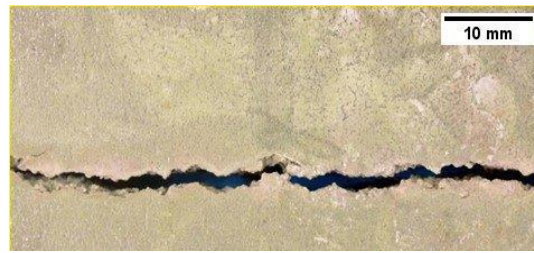
Figures 3 and 4 show tube A's internal surface and fracture images. The tube was sectioned into two longitudinal halves to examine the ID surface. The ID surface was generally intact with no significant wastage or deposition apart from the rupture crack as shown in

**Figure 3.** Tube A— ID Surface. The ID surface was generally intact apart from the rupture crack.

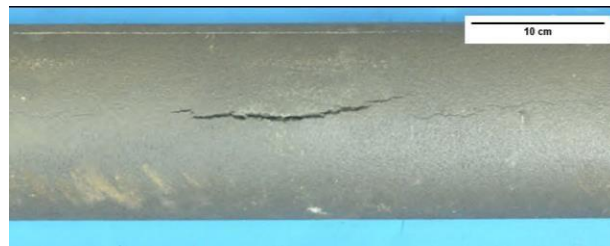
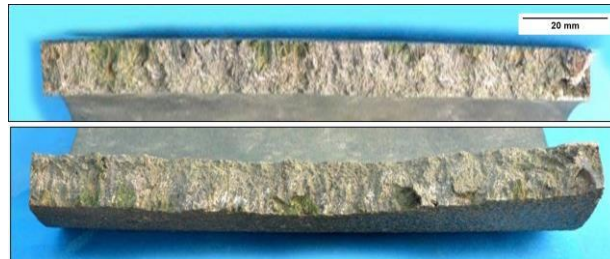
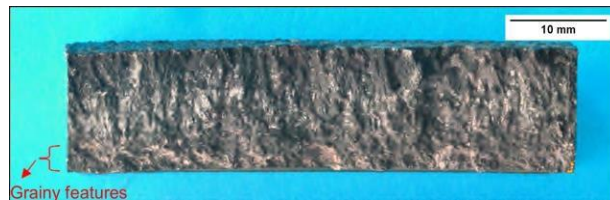
**Figure 4.** Tube A— Fracture Surfaces (a) overall view, (b) before cleaning and (c) after cleaning.

Figure 3. The rupture crack was later sectioned at its two ends to open for examination of the mating fracture surfaces (Figure 4). The fracture surface was greyish in appearance with scattered presence of adherent greenish scales or deposits. Grainy features were observed adjacent to the ID surface and extended transversely up to one-fourth of the wall thickness. The rest of the fracture surface revealed undulating ridge-like features which were oriented transversely across the tube wall.

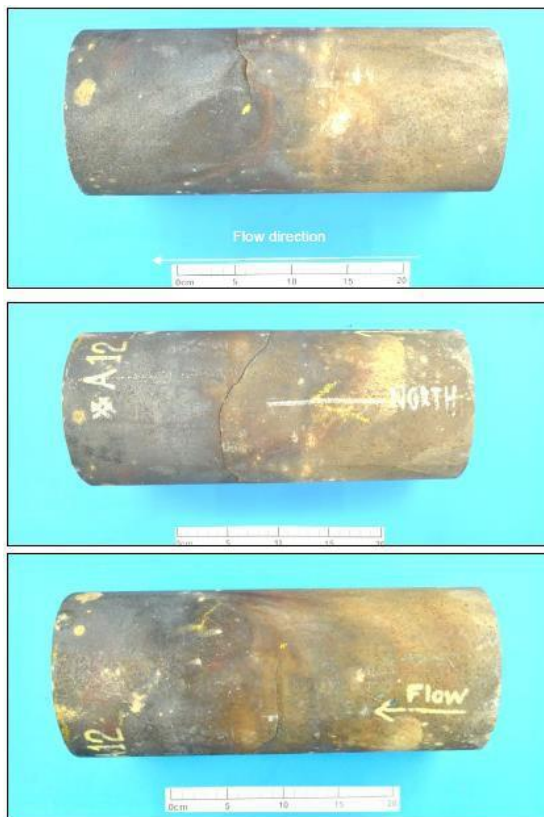
**Figure 5.** General Views of As-Received Tube B.

Figures 5 and 6 show the general views of the as-received tube B and the external surface respectively. The cut-out tube was 380 mm long. An approximately 260 mm long circumferential U-shaped crack was observed propagating transversely across up to two-thirds of the tube OD (Figure 5). The OD surface of the tube had a brownish appearance towards the upstream side of the fracture, which was likely associated with the insulation layer. The OD surface downstream of the fracture revealed a more darkish appearance. The crack appeared to follow a generally straight path between the two crack ends and became more jagged towards the two crack ends as shown in Figure 6.

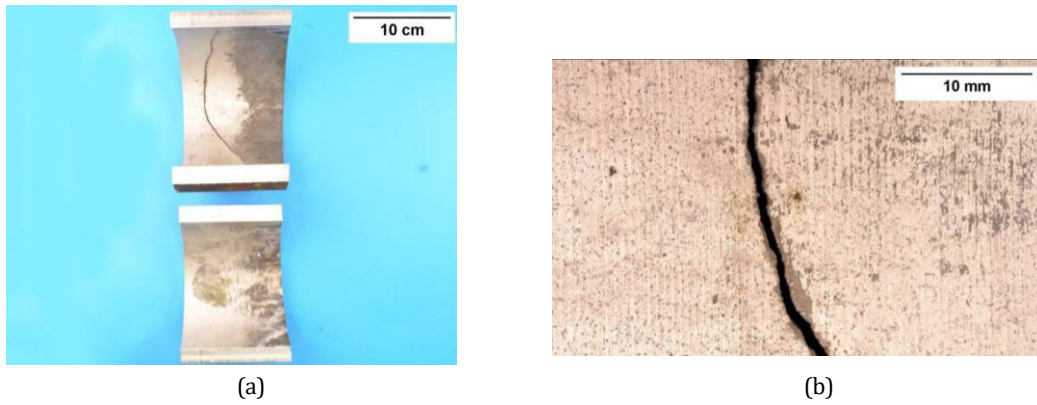
Figures 7 and 8 show tube B’s internal surface and fracture images. The tube was sectioned into two longitudinal halves to examine the ID surface. The ID surface was generally intact with no significant wastage or deposition apart from the rupture crack. The circumferential crack was later sectioned at its two ends to open for examination of the mating fracture surfaces (Figure 8). The fracture surface was generally covered with adherent darkish scales or deposits. A couple of relatively flat thumbnail regions, suggesting the initiation sites of the crack, were observed adjacent to the OD of the tube. Undulating ridge-like features were observed

Figure 7. (a) General view of ID surface and (b) Close-up view of ID surface of rupture in tube B.

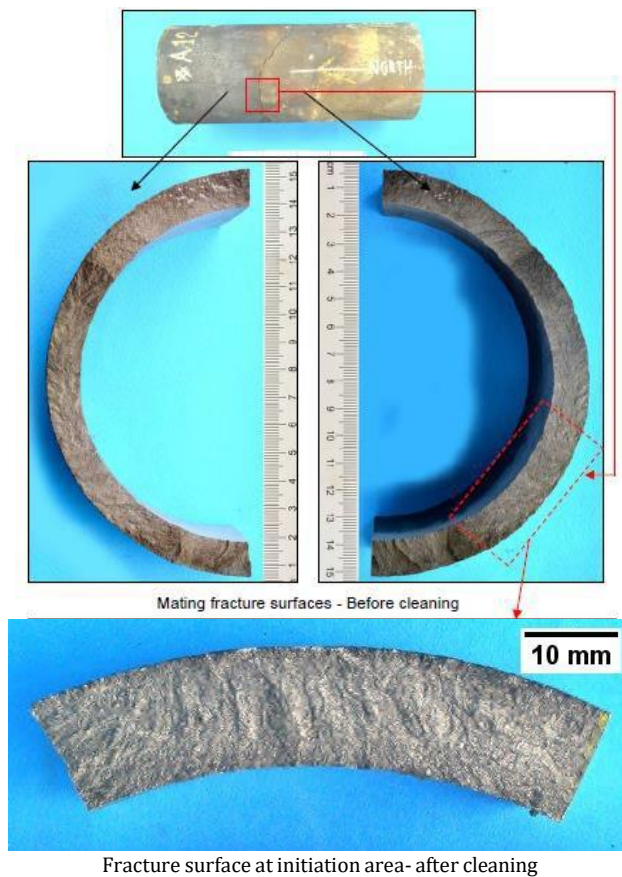
Figure 8. Tube B – Fracture Surfaces; before and after cleaning.

emanating from the thumbnail regions and propagating toward the two crack ends. The fracture surface also revealed grainy features adjacent to the ID of the tube.

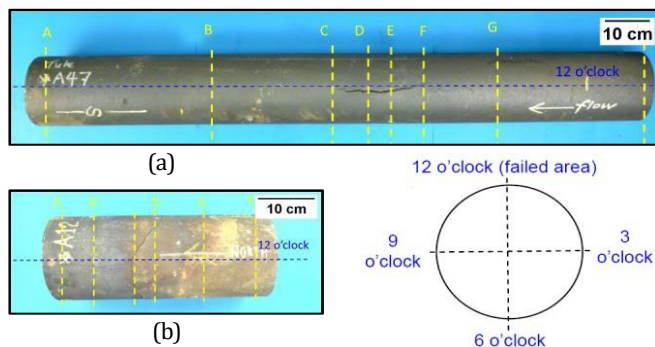
**Figure 9.** The two tubes with the locations for circumference measurements and wall thickness, (a) Tube A and (b) Tube B.

Both tubes A and B images with the locations for circumference measurements and wall thickness are shown in Figure 9. A dimensional check was conducted to measure the circumference and wall thickness of the two cut-out tubes. Pi-tape measurements were taken at, adjacent to and away from the cracks. Table 3 represents the circumference measurements on both tubes (Tubes A and B) at different locations. It was found that the

circumference of Tube A increased at locations D, E and F, which are associated with bulging events. This tube A had swelled with an increase of about 1.03% in circumference at the crack area, as compared to the intact region, which was located away from the crack. The thickness measurements were taken at the sections adjacent to the ends of the tube samples using a point vernier caliper. The

measurement results along the selected locations and wall thickness values are shown in Table 4. The thickness of the crack mouth was also reduced as compared to the intact areas due to the increase in circumference. Tube B showed no significant variation in its circumference and thickness at and away from the crack area.

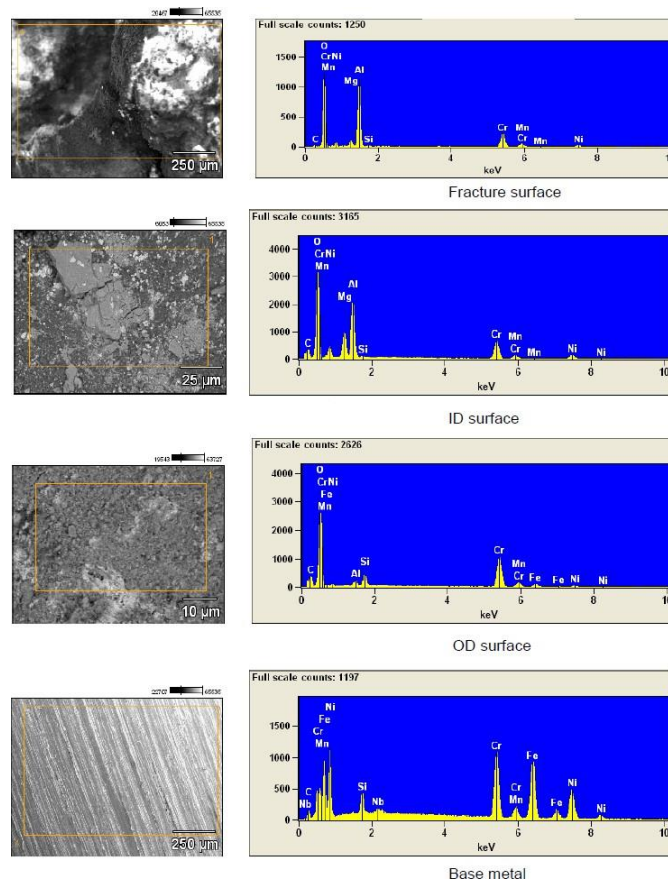
**Figure 12.** The EDX results on the fracture, ID and OD surfaces, and base metal of tube A.

The EDX results on the base metal, fracture, ID and OD surfaces of tubes A and B are tabulated in Table 5. In general, tube A revealed the existence of oxygen, chromium, nickel, aluminium, carbon, magnesium, silicon, manganese and iron (Figure 12). While the EDX results on the base metal, fracture, ID and OD surfaces of tube B generally revealed the presence of oxygen, chromium, nickel, aluminium, iron, carbon, magnesium,

silicon, manganese and calcium (Figure 13). The elemental contents were essentially associated with oxidation products of the base metal accompanied by some contaminations from the exposed environment. The magnesium, aluminium and carbon contents were likely associated with the catalyst and service medium of the tubes. No significant presence of corrosive species was detected on both tubes A and B.

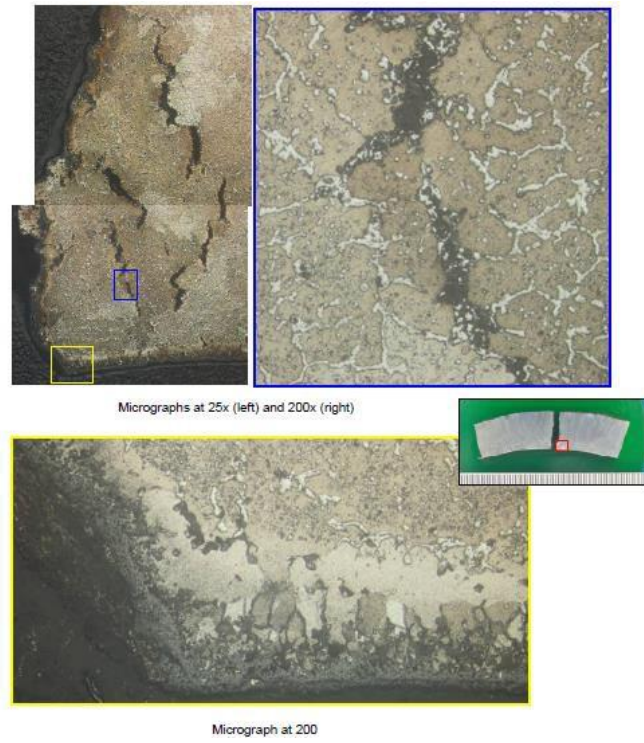
**Figure 14.** Metallographic Section of Tube A (Section #A) – Across Rupture Mouth (ID).

Sectional metallographic examination was conducted transversely across the following locations of the two cut-out tubes. Figures 14 and 15 display the macrographs and micrographs of tube A. In ruptured section #A, creep voids were observed along the rupture surface (Figure 14). The rupture surface was covered with an oxide scale

due to post-rupture exposure to the high-temperature service environment. Numerous sub-surface fissures at the ID, formed by aligned and linked creep voids were observed (Figure 14). The failure of the tube was consistent with creep rupture from the ID. Slight oxidation was observed at the OD and ID surfaces. There was no significant presence of creep voids observed in the reference intact section.

In conclusion, the failure of tube A revealed a form of damage known as creep rupture, which was evidenced by the presence of bulging and extensive presence of creep voids and fissures in the locally affected area of the tube. This bulging indicates that the tube experienced time-dependent deformation at elevated temperatures, leading to the development of internal stress and ultimately the rupture of the tube. Creep rupture is a common mode of failure in materials subjected to sustained high temperatures and mechanical stress, and the observation of bulging is a clear indicator of this damage mechanism.

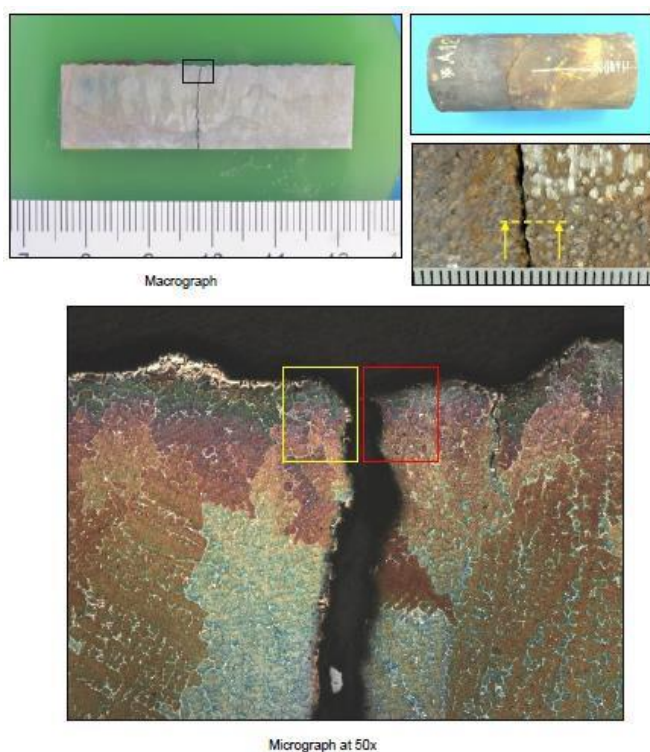
The macrographs and micrographs of the examined section on tube B are shown in Figures 16, 17 and 18. In section #C1 (across the middle of the crack), it was observed that the crack path across the tube thickness was generally straight apart from a slightly jagged morphology near the OD, resembling intergranular crack propagation from the OD in Figure 16. There was also a similar intergranular incipient crack propagation from the OD adjacent to the through-thickness crack, as shown in Figures 16 and 17.

**Figure 16.** Metallographic Section of Tube B (Section #C1) — Across Middle of Crack Length. It was observed that the crack path across the tube thickness was generally straight apart from a slightly jagged morphology near the OD, resembling intergranular crack propagation from the OD.

However, the failure on tube B was primarily attributed to intergranular crack initiation at the OD surface. This was likely due to thermal shock cracking, which is when rapid temperature changes cause stress and lead to cracks between grain boundaries. The subsequent crack propagation within the tube was primarily driven by a fatigue mechanism, indicating that the ongoing cyclic loading and unloading caused the cracks to grow, eventually leading to the tube's failure.

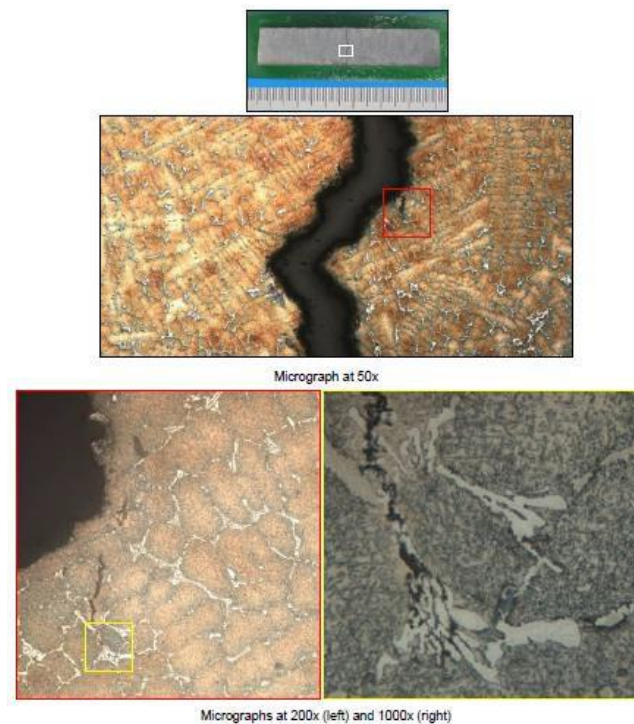
The crack propagation towards the crack end in section #C2 (Figure 18) was generally transgranular in nature. The exposed surface along the crack length had generally been oxidised due to post-fracture exposure. A slight extent of creep voids was observed along the crack, likely due to the cracked tube's reduced strength capacity as seen in Figure 18. The crack initiation of the tube appeared to be associated with embrittlement, likely due to thermal shock failure. The subsequent crack propagation was consistent with the creep-fatigue cracking mechanism. Slight oxidation was observed at the OD and ID surfaces. The condition of the reference section was generally satisfactory with no presence of cracks.

**Figure 18.** Metallographic Section of Tube B (Section #C2) – Across Crack End. The crack propagation towards the crack end was generally transgranular.
