Incoloy 800HT Weldolet Integrity in Hot Collector: Replica Testing Insights

Nur Farhana Hayazi^{a,*}, Ku Adri Azhan Ku Mohamad^a, Junaidi Che Halim^a and Shaiful Rizam Shamsudin^b

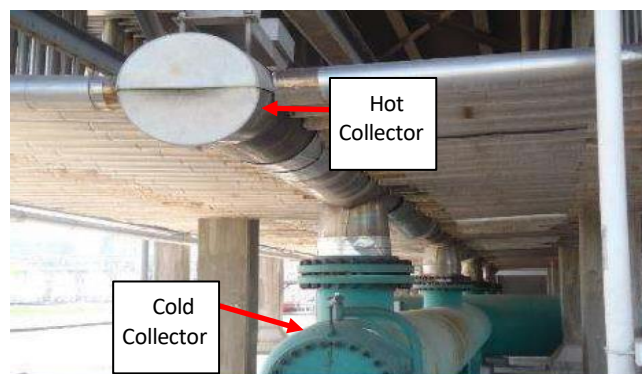
Figure 1. Overview of the hot and cold collector at the primary reformer.

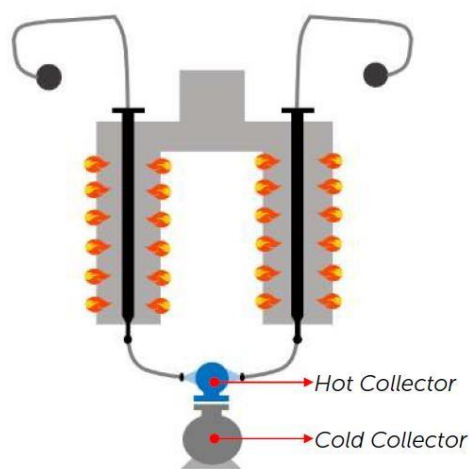
Figure 3. Schematic diagram of the hot and cold collector designed for side-firing and operating at temperature 910°C for this work.

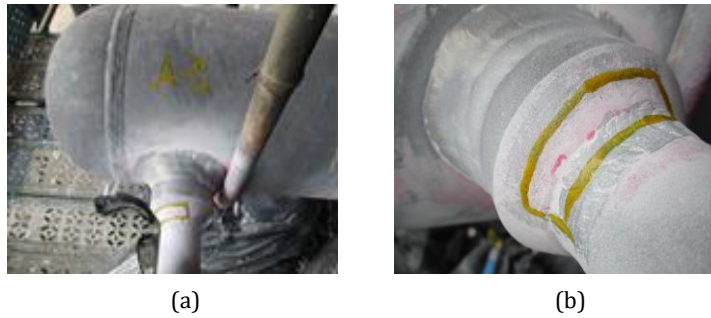
Figure 4. Hot collector weldolet of joint A, (a) general views and (b) showing linear circumferential crack of 10 mm.

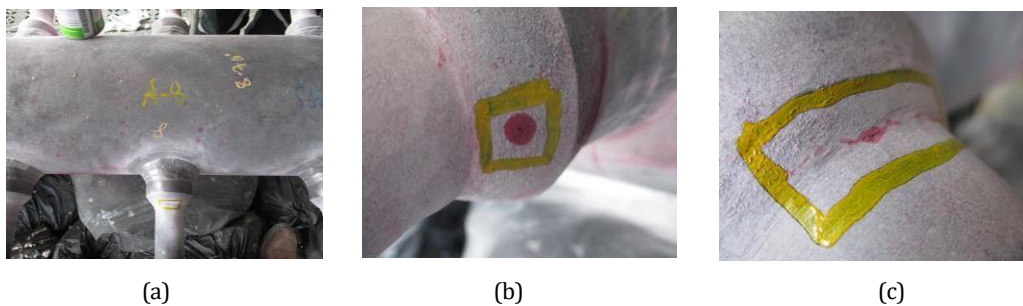
Figure 5. Hot collector weldolet of joint B, (a) general views, (b) showing the rounded crack of 6 mm and (c) with linear circumferential crack of 10 mm.

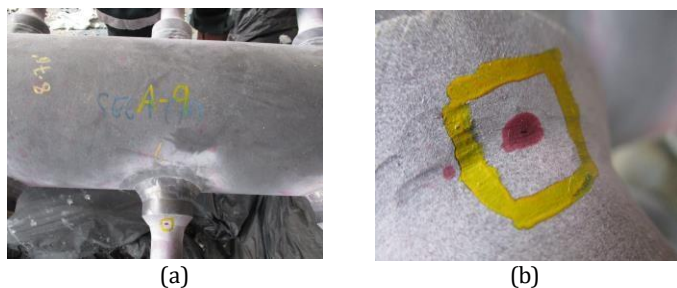
Figure 6. Hot collector weldolet of joint C, (a) general views, (b) showing the rounded dye penetrant finding of 6 mm, facing south and the location at 12 o'clock.

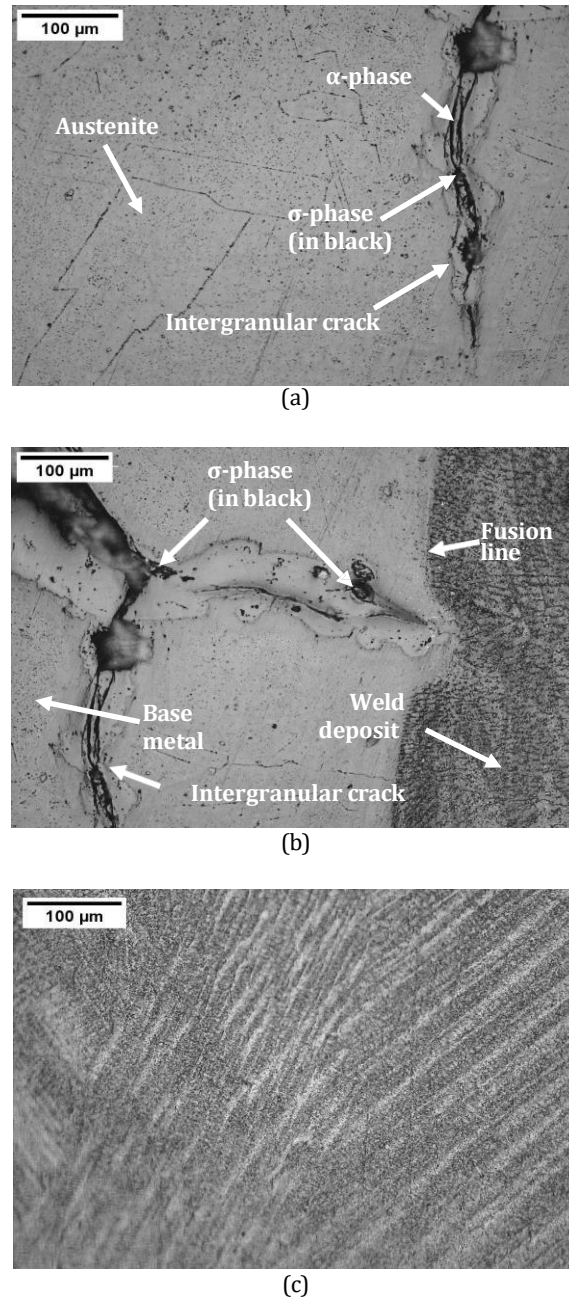
Figure 8 Microstructural images of hot collector weldoilet of joint A where (a) BM, (b) HAZ and (c) WELD.

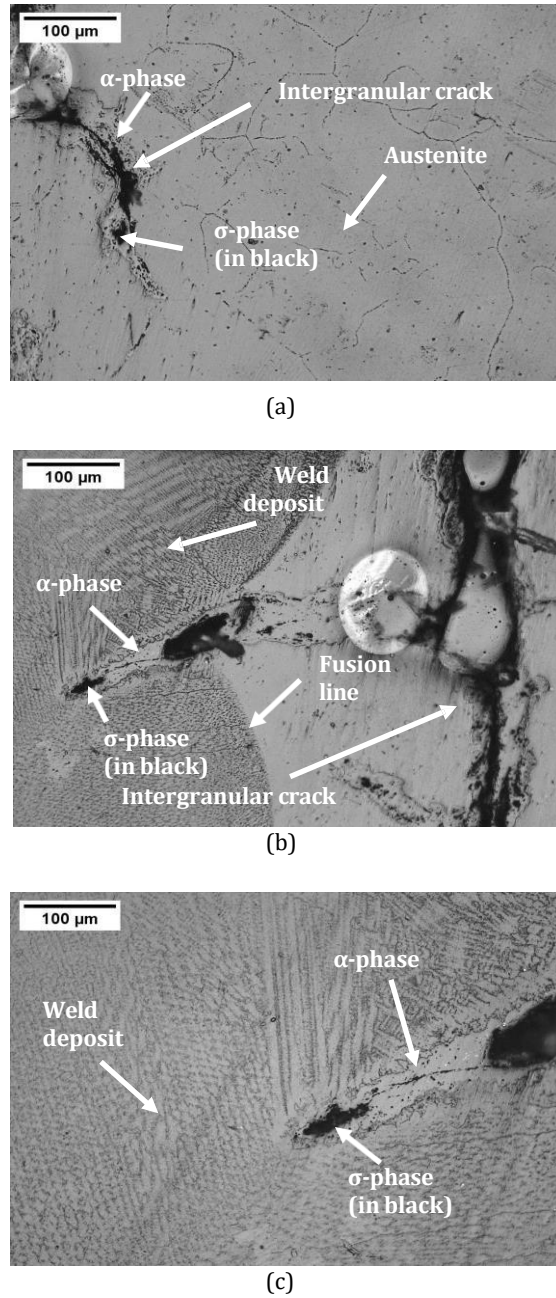
Figure 9 Microstructural images of hot collector weldolet of joint B where (a) BM, (b) HAZ and (c) WELD.

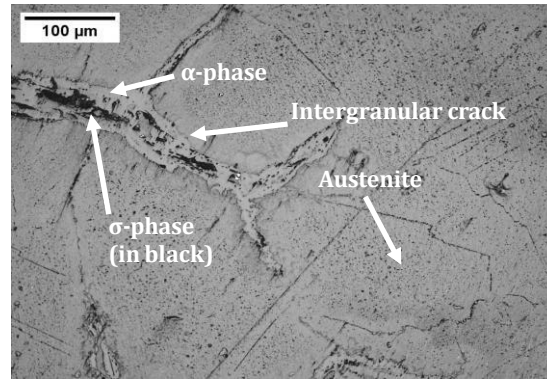
Consequently, this creates Cr-depleted zones adjacent to grain boundaries, brought about by the formation of chromium carbides that remove chromium from the solution. This chromium depletion renders the grain boundary area "sensitized," with the depleted region acting as anodic relative to the bulk material, resulting in accelerated corrosion along the grain boundaries.

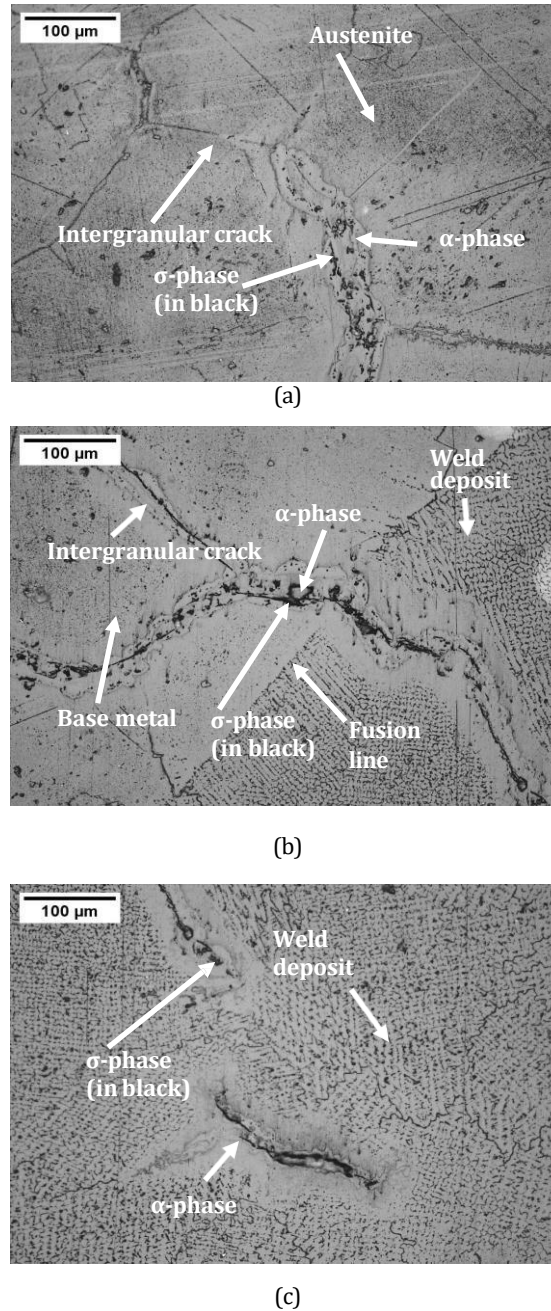
Figure 11. Microstructural images of hot collector weldolet of joint D where (a) BM, (b) HAZ and (c) WELD.

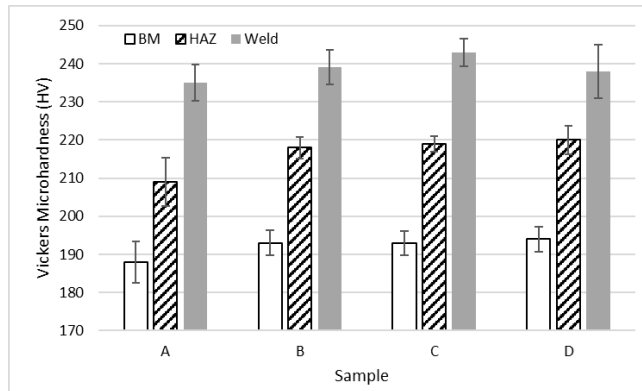
Figure 12. Vickers microhardness test results on hot collector weldolet of joints A, B, C and D at three different welding zones.
