Wear Characteristics of 22MnB5 Boron Steels When Applied As Cutting Tool In Dry And Wet Machining Aluminum Alloy

22MnB5 boron steel, an Ultra High Strength Steel (UHSS), is celebrated for its exceptional strength and wear resistance, making it highly valuable in automotive and other industries where lightweight materials are essential. Its superior wear resistance also makes it suitable for use in cutting tools. This study aimed to evaluate the performance of 22MnB5 boron steel as a turning insert for metal machining, specifically in relation to cutting speed and cutting environments. The 22MnB5 boron steel blanks were laser-cut into round shapes with a thickness of 2.6 mm and a diameter of 12 mm, following the RGN 120300 standard. Machining tests were performed on AA 6061 aluminum alloy under both dry and wet conditions, with cutting speeds ranging from 100 to 450 m/min. The outcomes highlighted that 22MnB5 boron steel is effective for machining AA 6061, with tool wear stabilizing between 200 and 350 m/min. Tool wear ranged from 0.15 to 0.27 mm in dry conditions and was reduced to 0.08–0.18 mm in wet conditions. At lower speeds, built-up edges were the predominant wear mechanism,

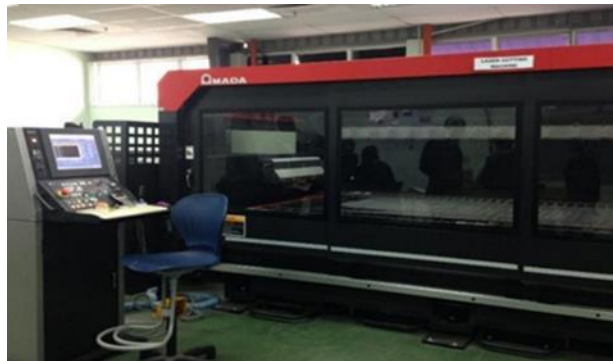
Figure 1. Laser facility employed to cut 22MnB5 Boron steel.

Initially, the 22MnB5 boron steel was sourced from the industry and subsequently subjected to hardening and heat treatment through a hot stamping process. It was then laser cut according into the shape of a RNGN 120300 tool, as shown in Figure 1. Figure 2 depicts a sample product of a 22MnB5 component being cut from a hot-stamped part. Figure 3 depicts 22MnB5 samples that have been shaped into RNGN 120300 insert. Tables 1 and 2 show the mechanical and chemical properties of 22MnB5 boron Steel, respectively.

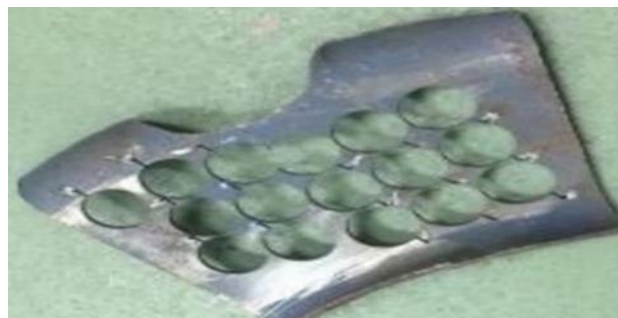
Figure 2. Example of 22MnB5 component sourced form industry.

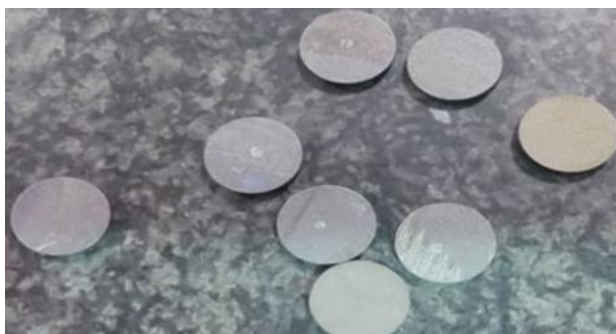
Figure 3. 22MnB5 Boron Steel with the shape of RNGN 120300 turning insert.

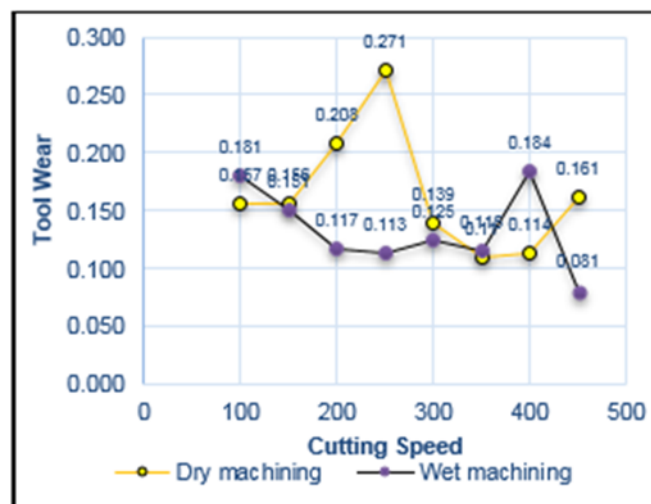
Figure 6. Comparison of wear values across dry and wet conditions when machining 22MnB5 turning inserts with AA 6061 aluminum alloy.

Figure 6 illustrates the comparison of wear values across dry and wet conditions when machining 22MnB5 cutting tool with AA 6061 aluminum alloy. Observations indicate that wet machining results in less tool wear compared to dry machining. For wet machining, tool wear decreases as cutting speed increases, except at the 400 m/min speed where this trend does not hold.

The aforementioned observation at the Figure 6 indicates that the use of dry machining techniques leads to an unstable pattern of wear progression. Observations of the results suggest that the uncertainty in wear development may be attributed to the formation of a Built-Up Edge (BUE). A BUE is a layer of workpiece material that adheres to the rake face of a cutting tool due to the heat generated during the cutting process [13, 16]. As an illustration, when analyzing a speed of 250 m/min, the wear measurement attains its highest point at 0.271 μm. Further on, it can be observed that the wear value exhibits a gradual decline as

the cutting speed is elevated to 300 m/min, to 0.139 mm, and further decline to 0.114 mm at 400 m/min. Further observation of BUE is shown in Figure 7.

In the context of wet machining, a noticeable trend of decreasing tool wear has been observed as cutting speed increases. At the beginning of machining, the tool recorded wear at 0.181 mm. At a cutting speed of 350 m/min, the measured tool wear decreased to 0.1 mm. However, the tool wear increased sharply to 0.184 mm at 400 m/min, before dropping back to a minimum of 0.081 mm at 450 m/min cutting speed. Similar like in the case of dry cutting, the uncertainty in wear development could be attributed to the presence of a BUE formation, which adheres to the surface and causes a significant rise in wear measurement [13, 16]. The structural integrity of the BUE deteriorates as speed increases, resulting in a reduction in wear when the speed reaches 300 m/min due to the progressive disintegration of the BUE. However, the effect of the BUE in wet machining appears to be less pronounced compared to dry cutting.

In summary, the observed wear during dry machining exhibited a range of 0.15 to 0.27 mm. In the context of wet machining, the observed tool wear exhibited a range of 0.08 to 0.18 mm. The use of coolant in wet machining has been found to result in a mean reduction of wear by 15.8%. The wear regime seems to have reached a stable state, with a cutting speed ranging from 200 to 350 m/min. Employing coolant fulfills two primary roles which are to cool the cutting zone and offers lubrication to decrease friction between the cutting tool and the workpiece. In addition, coolant serves the purpose of effectively removing debris from the entangled material at the cutting region [14]. On the other hand, the round cutting tool utilised in this study possesses a significantly larger nose radius (12 mm) in comparison to conventional cutting tools (ranging from 1.2 to 1.6 mm). Consequently, the increased nose radius of the tool resulted in a correspondingly larger contact area with the workpiece. Thus, a significant quantity of energy is necessitated in order to induce shear deformation in the metal, leading to the generation of elevated temperatures at the cutting interface [15].
