## Influence of accelerated aging (temperature and acid attack) on the mechanical properties, structural, and morphological characteristics of high-density polyethylene sewer pipes

### ABSTRACT

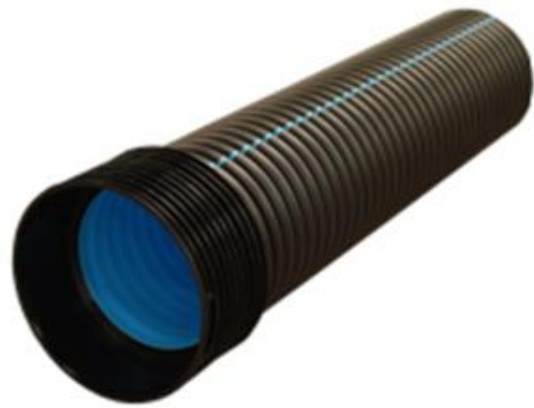
Figure 1 Standard corrugated double wall HDPE pipe.

The inner wall of a corrugated double-wall high-density polyethylene pipe (NM EN 13476-2) with a 1000 mm diameter served as the study's standard tensile specimen (Figure.1). The samples were obtained by transversely cutting the tube (Figure.2).

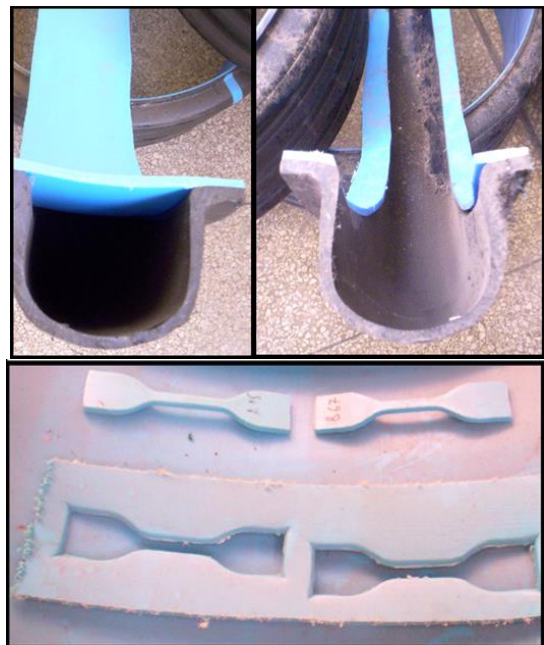
Figure 2. Different steps of cutting for chemical degradation test.

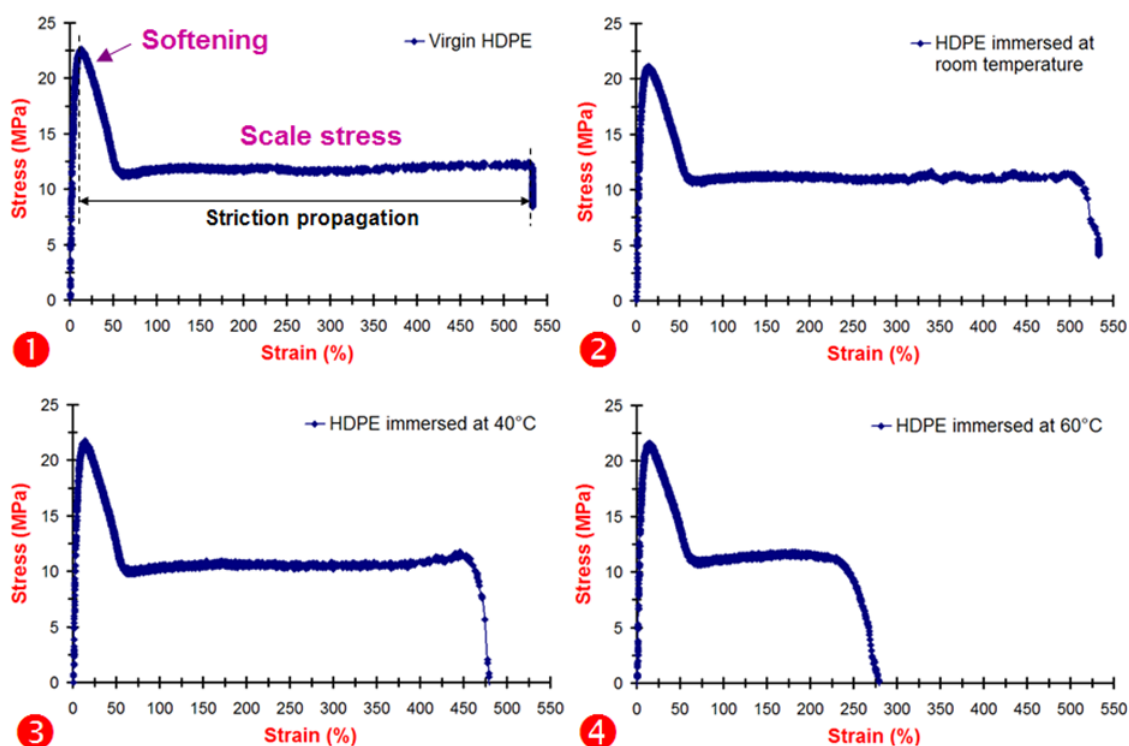
**Figure 3.** Effects of aging temperature on the tensile strength curves of HDPE samples: virgin (1), aged at room temperature (2), aged at 40°C (3) and 60°C (4) for 92 days immersion in sulfuric acid.

Figure. 3 displays the results of how aging affects some mechanical properties of HDPE. In our study and as shown on the graphics, each mechanical characteristic is pictured by a mean of three tests. Figure. 3 presents the stress variation according to the deformation of the studied material tested under three temperatures.

The three schemes indicate that the characteristics of all stress-strain curves are the same. An abrupt decrease in stress near the yield point can be observed following an initial elastic phase. At this point (increased elongation without further increase in tensile strength), the local necking of the specimen started, and the samples were susceptible to elongation and strain hardening until they broke their original gauge length. The elongation (strain at break) of the samples aged at 25, 40 and 60 °C is reduced compared to the untreated sample as illustrate in figure 4. The loss of

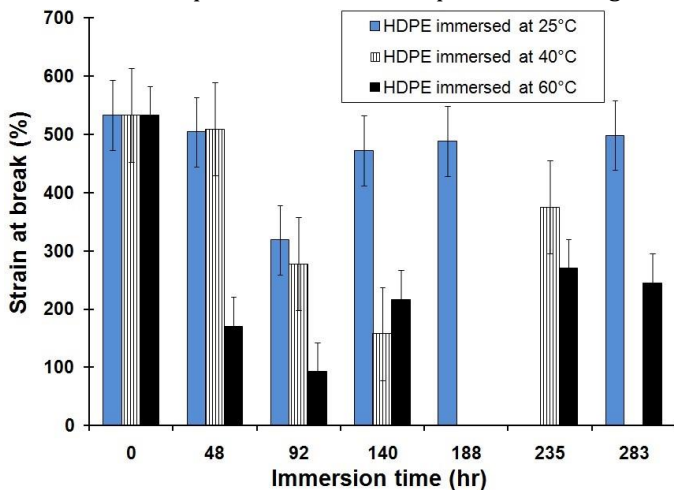
**figure 4.** Development of the elongation at break as a function of

the aging time at different temperatures.

The smallest dimension at the point of fracture is influenced by the absorption of the solution. An increase in immersion time and temperature increases the thickness of the sample at the point of fracture (Figure.4 and Figure.5) after the tensile test. And it didn't change only because of the absorption of the solution before the tensile test.

During the experiment, we added small quantities of diluted sulphuric acid ( $H_2SO_4$ ) solution to the initial solution used for immersion of the HDPE samples to maintain the pH at 1. Under the effect of aging and temperature, the elongation at break (%) decreased significantly (Figure.4) at the time of testing.

In all cases, a clear aging effect on the elongation (or strain at break) and the stress at break, which shows a sharp drop after a few days, could be observed. However, the aging temperature continues to have an impact on this decline. Mechanical characteristics drastically deteriorate as the temperature rises. At a temperature of 25°C, the elongation decreases from 525% to 300% within a time span of 0 to 92 hours. When the temperature is 40°C, the elongation decreases further from almost 500% to 100% over a period of 0 to 140 hours. However, at 60°C, the reduction becomes more significant, with the elongation varying from 525 % to 75 % within the time interval of 0 to 140 hours.

According to Figures 4 and 5, the variation in the percentage of (stress at break) and (strain at break) can be explained by the diffusion process of sulfuric acid molecules in the molecular structure of the polymer. In addition, the increase in the percentage deformation of the sample after being returned to its initial state can be attributed to the saturation (or equilibrium) state of the sample following its immersion in acid at different temperatures. Mouallif et al. have already studied the diffusion process under similar conditions [26]. These outcomes are in line with Pegoretti's findings [18], which examined how time and temperature affect the flexural strength of an aged composite.

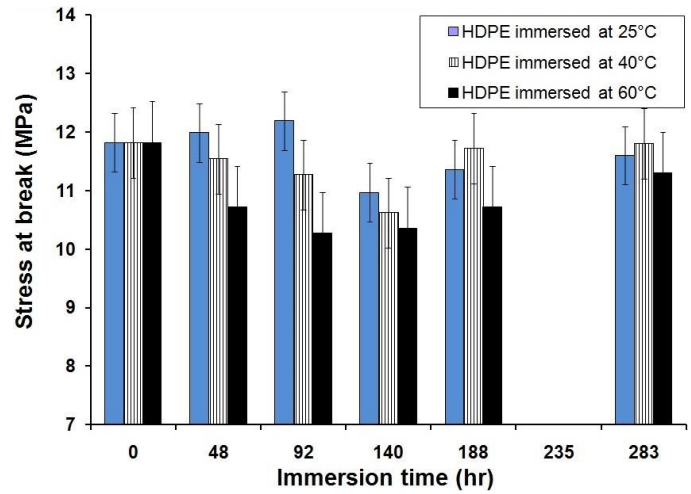
**figure 5.** Development of the stress at break as a function of the aging time at different temperatures.

Figure.5 depicts the stress at break. At a temperature of 25°C, the stress at break increases from 11.9 MPa to 12.2

MPa within a time range of 0 to 92 hours. Subsequently, it decreases from 12.2 MPa to 11 MPa during the period of 92 to 140 hours. When the temperature is 40°C, the stress at break decreases from 11.9 MPa to 10.5 MPa within the time span of 0 to 140 hours. However, it then increases from 10.5 MPa to 11.9 MPa between 140 and 283 hours. At 60°C, the stress at break decreases from 11.9 MPa to 10.2 MPa within the time interval of 0 to 92 hours, and subsequently increases from 10.2 MPa to 11.2 MPa from 92 to 283 hours. Therefore, the influence of temperature is readily apparent.
